FINAL ACCIDENT REPORT

AIR TRACTOR - 802A

EC-JLB

FINAL ACCIDENT REPORT Nr. 12/ACCID/2012

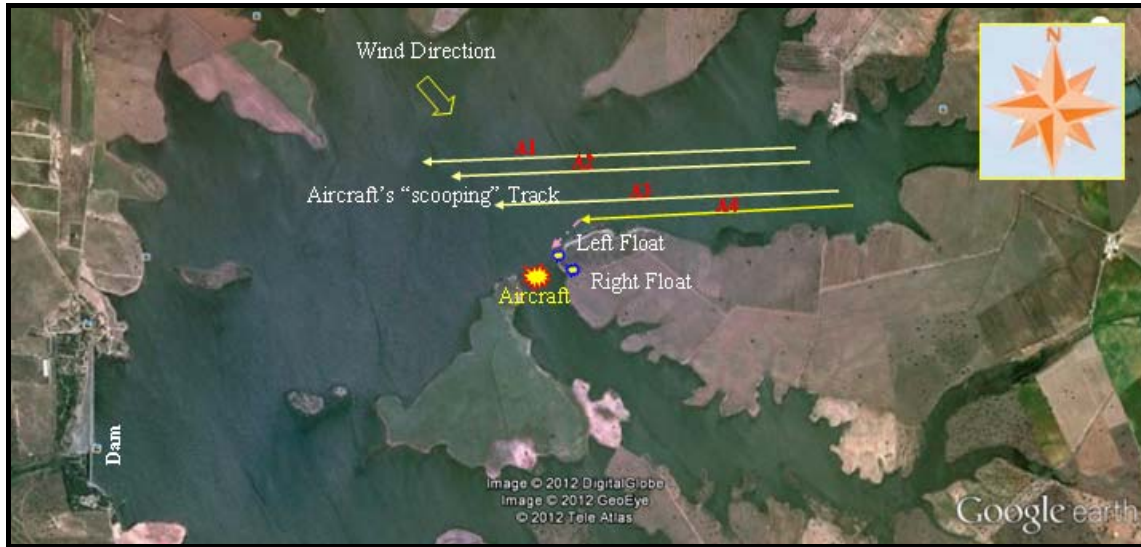
Picture Nr 2

After refuelling, the pilot accelerated for take-off and, when close to lift-off speed, entered wake turbulence zone, created by preceding aircrafts, got serious control problems, actuated emergency water discharge lever and when control was recovered, the aircraft was pointing about 45° to the left of intended heading. Before he could lift-off, aircraft floats collided with the ground in the lake margin and left float detached. The aircraft flew over a small

neck of land and crashed, nose down, some meters ahead in another inlet, right float broke up (becoming afloat and drift) and the aircraft sunk, almost immediately (*picture nr 2*).

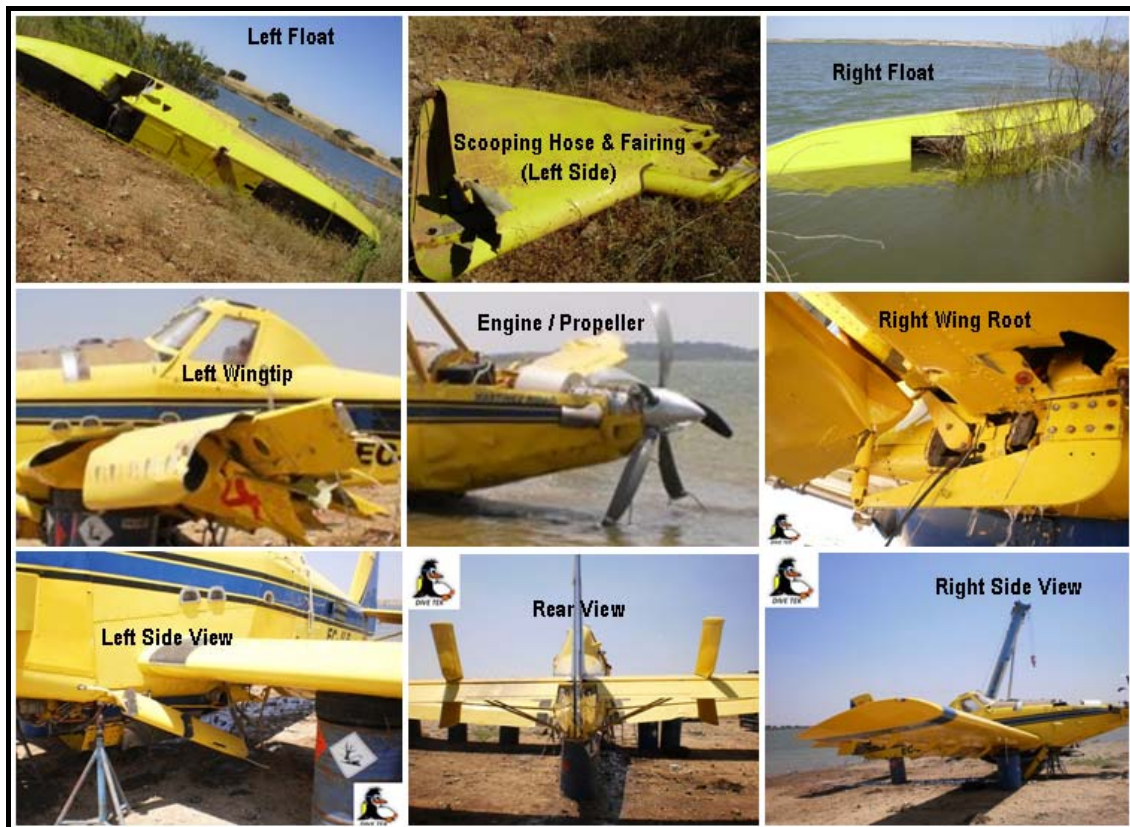
Picture Nr 3

The aircraft suffered substantial damage, which could justify not to be repaired, namely both floats separation and heavy damage to their fixing points and floats themselves, left wing tip and outer wing damage caused by water impact, right wing underwing crack (near its root) with fuel tank leak, bent propeller blade tips and light damage (scratches and dents) on fuselage skin and flight control surfaces (*picture nr 3*).

Being the aircraft immersed in the water it's supposed to have suffered equipment and engine substantial internal & external damage.

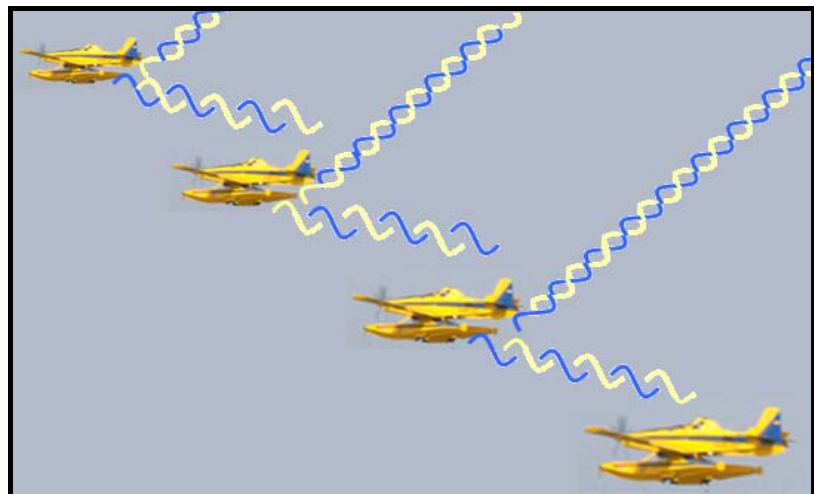
Picture Nr 8

Lateral spacing between aircrafts allowed every aircraft to avoid preceding one (in case of failure and rejected take-off manoeuvre), proceeding in front; while longitudinal spacing kept each aeroplane outside previous aircraft wake, when moving on lake surface (*picture nr 8*).

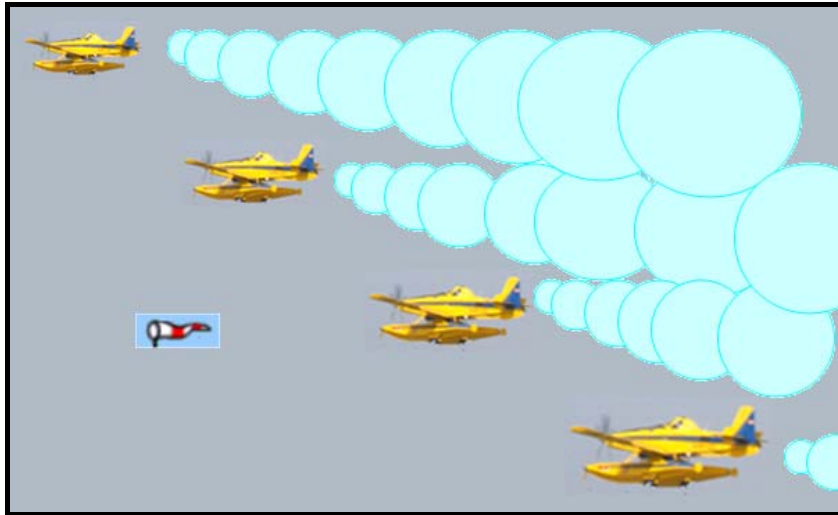
Picture Nr 9

With the planes heading into the wind, wake turbulence waves propagate straight behind and, due lateral separation between aeroplanes, forward aircraft generated turbulence doesn't interfere with following aircraft, which keeps flying undisturbed (*picture nr 9*).

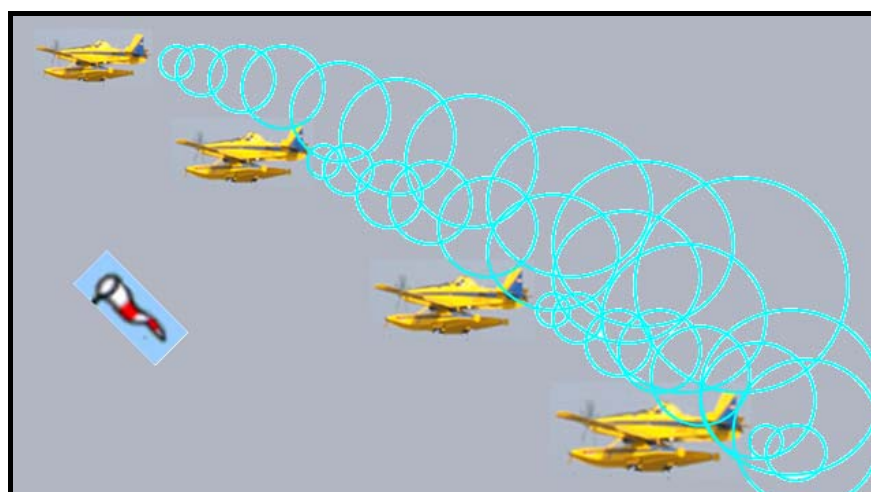
Picture Nr 10

In spite of its low intensity, the wind caused a deviation to the left of wake turbulence waves (*picture nr 10*).

In such a case, wake turbulence generated by preceding aircrafts was interfering with following ones, creating difficulties for its controllability.

If aircrafts 2 and 3 were not too much affected by turbulence and pilots managed to control them without problems, aircraft nr 4 was suffering the influence of all other aircrafts generated turbulence, having its pilot a great difficulty to control the aircraft. In fact, at rotation, after scooping, he lost control of the aircraft and, when he regained it, the aircraft was pointing about 45° to the left, against the margin. He couldn't lift-off before impacting the ground with both floats, lost one of them and crashed a few meters ahead.

If the leader had adopted a right line formation, wake turbulence waves would move outwards of the subsequent aircrafts and the manoeuvre would be facilitated.

“To study the introduction, on his Operations Manual, of more detailed information regarding lateral wind effects on aircraft’s performance and control during group scooping manoeuvres, or other similar operations (like simultaneous take-off and landing manoeuvres) suggesting the use of required procedures, namely different formation layout, in order to minimize or avoid such negative effects” (SR 05/2012)
