TECHNICAL REPORT A-020/2011

Date and Time	Wednesday, June 29, 2011; 5:15 p.m. local time
Place	L'Ampolla (Tarragona)

Tuition	EC-LBG
type and model	AT-802A AIR TRACTOR
Exploitative	AVIALSA T-35, SL

REPORT

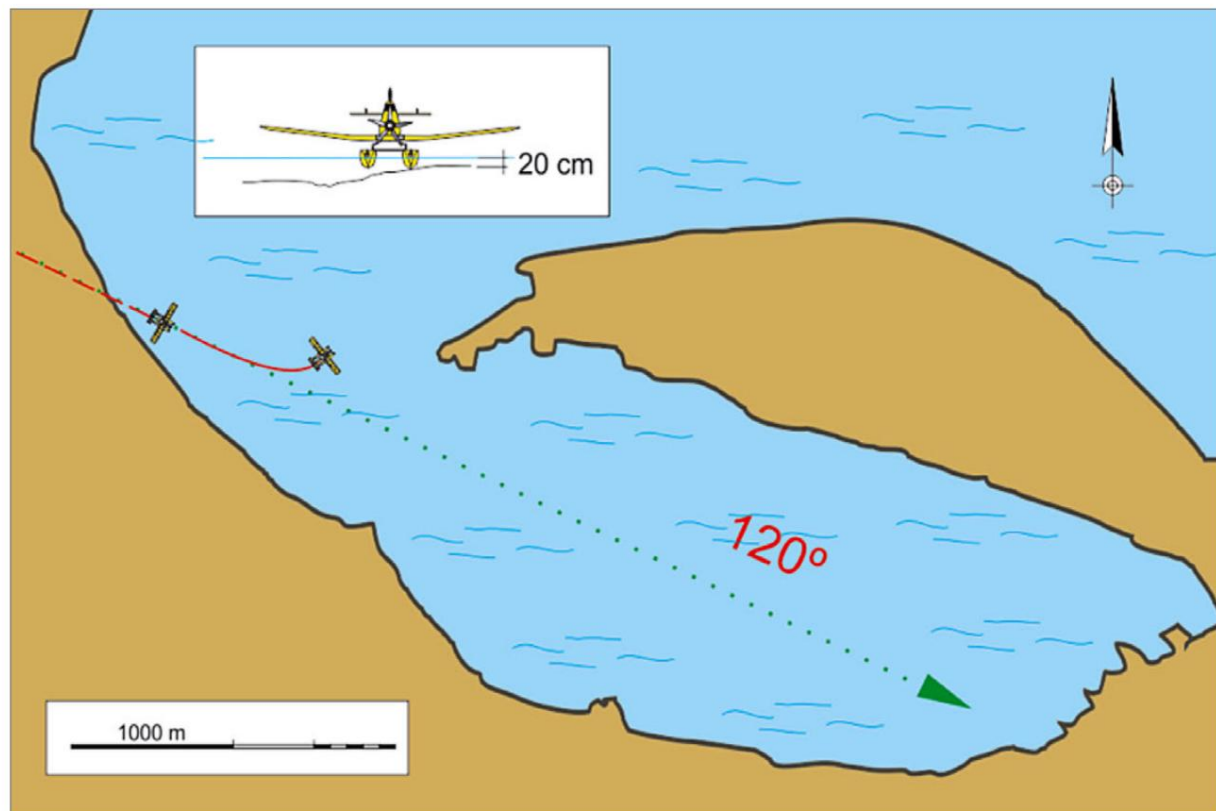
His attempts to correct with the right pedal and applying power were unsuccessful and he opted to make an emergency ditching, which was very brief, as the aircraft was stranded on top of a sandbank that was barely 20-30 cm deep that was not seen by the pilots in the aerial reconnaissance of the area. The heading presented by the aircraft once grounded was 80°.

Figure 1 shows the entry course of the aircraft to the recharge area and the final location where it was left.

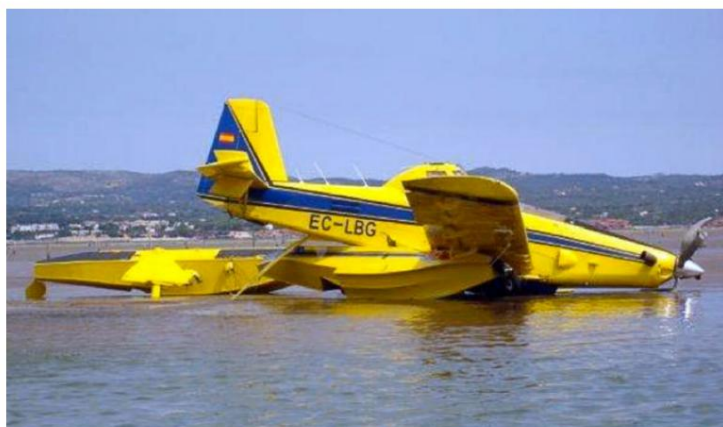
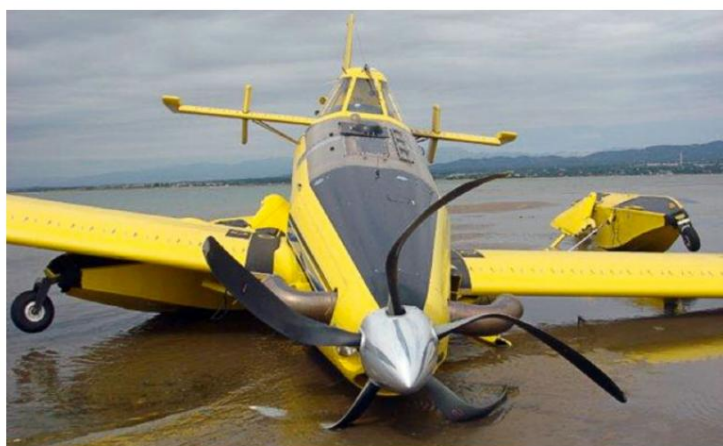
The two aircraft floats detached and the fuselage rested on the right float. The aircraft had other visible damage to the engine propellers, wings and fuselage.

- Damage to the entire fuselage. • Damage to the gate assembly. • Significant damage to the left demiplane, affecting the control surfaces And control.
- Damage to the right wing, with slight damage to the control surfaces and control.
- Damage to the motor base. • Destruction of the propeller. • Damage to the engine, with breakage of the power box and internal damage. • Breakage of the uprights of both floats, which were detached from the aircraft.
- Significant damage to the floats.

Figures 2 and 3 show the state of the aircraft after the accident.

At the moment of contact with the water, the depth was adequate, since the yaw occurred later, after having stabilized the speed and preparing to lower the scoops. It was at that moment that he found himself in such a situation that below his left float there was only a scant 20 cm of depth, while below his right float there was sufficient depth. Thus, the left float made contact with the sand and caused a yaw to the left and deceleration; deceleration that became more intense when both floats climbed the sandbar and caused structural damage to the uprights that caused both to detach.

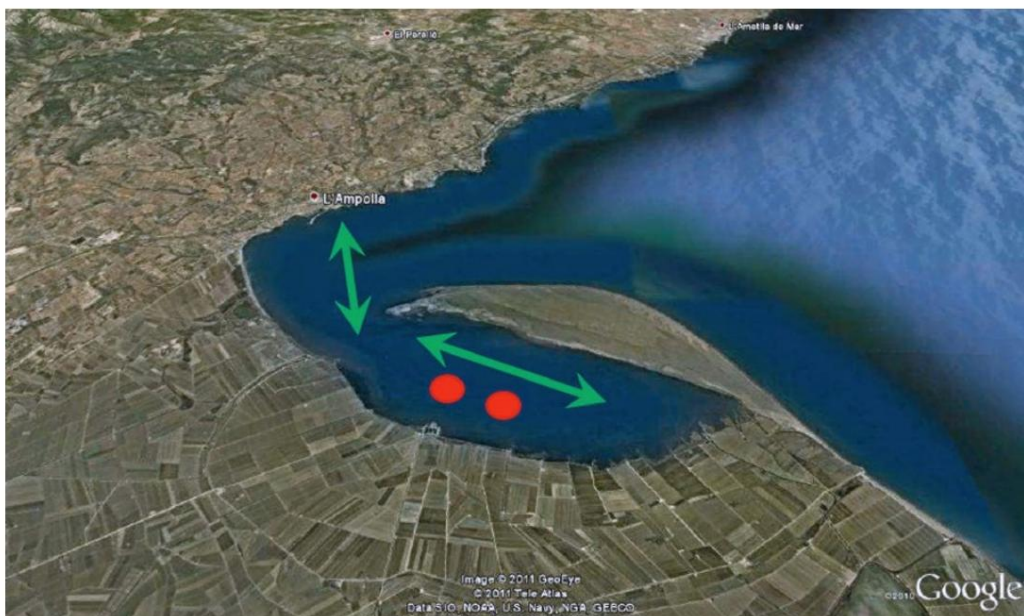
NORTH EBRO DELTA

Wide areas for loading. Pay attention to the swell and distance between waves in less protected areas. Large crop areas in the vicinity.

Said documentation preferably indicated two areas in the northern part of the Ebro Delta, with defined directions. The water recharge in the case of this accident was carried out in an area that is intermediate between the two that are proposed and is not related to them.

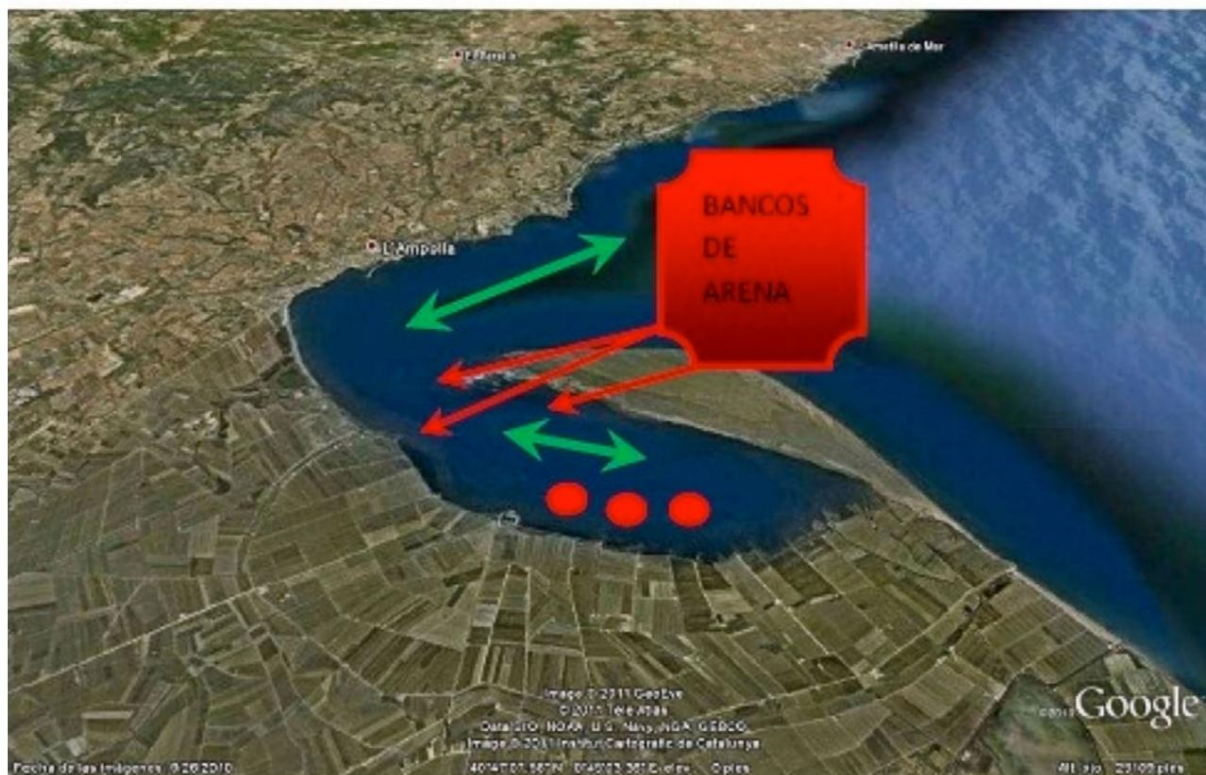
DELTA DEL EBRO NORTE

After the accident, the document was revised on August 17, 2011, and the new information related to the northern area of the Ebro Delta became:

Zona Delta, con abundantes bancos de arena. La zona central del estrechamiento presenta un carril con profundidad, limitado a los lados y en su entrada con bancos de arena. El carril central es ancho, apto siempre que sus límites queden nítidamente a la vista. Comentan los pescadores, que este banco de arena esta creciendo rápidamente, haciendo temer que termine anulando la renovación de agua ya que puede llegar a cerrar y estancar la zona.

REC 09/12. AVIALSA T-35, SL, as responsible for the operation, is recommended to include in the Operations Manual, in the section on additional information that must be carried on board, documentation on the specific areas recognized for water recharge.
