FINAL ACCIDENT REPORT

AIR TRACTOR - 802A

EC-JLB

FINAL ACCIDENT REPORT Nr. 12/ACCID/2012

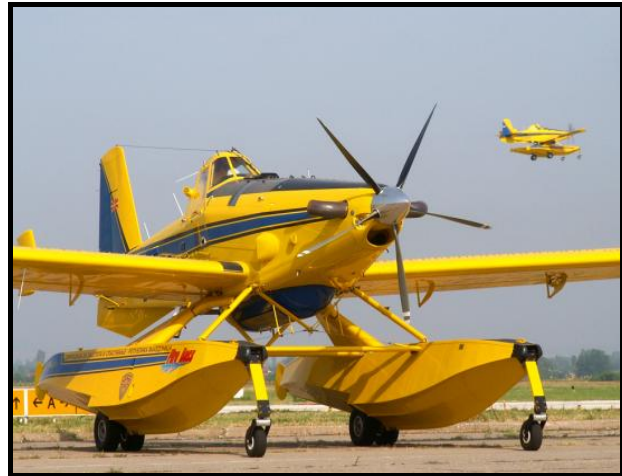
Picture Nr 4

The aircraft (*picture nr 4*) was a single engine, low wing and single pilot aircraft, specially prepared for wildfire fighting. Deriving from a previous generation of fire fighters, it was equipped with a water scooping system capable of scooping 820 USG of water in 30 seconds, for what floats had been installed, incorporating a wheeled undercarriage for land operation, becoming more versatile and efficient than his predecessor.

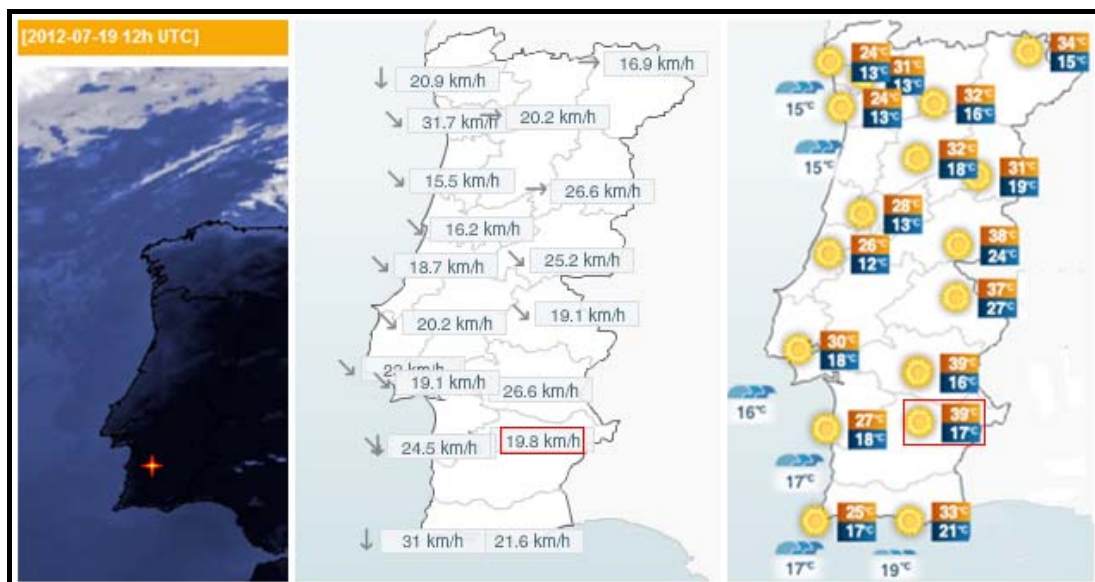
Picture Nr 5

The weather was fine, with clear sky, light to moderate North-westerly wind, high air temperature, capable of reaching 39°C (*picture nr 5*).

By accident time, the wind was blowing from 310° with 08kt and the temperature was 33°C, as meteo information from Beja military aerodrome (LPBJ) bellow.

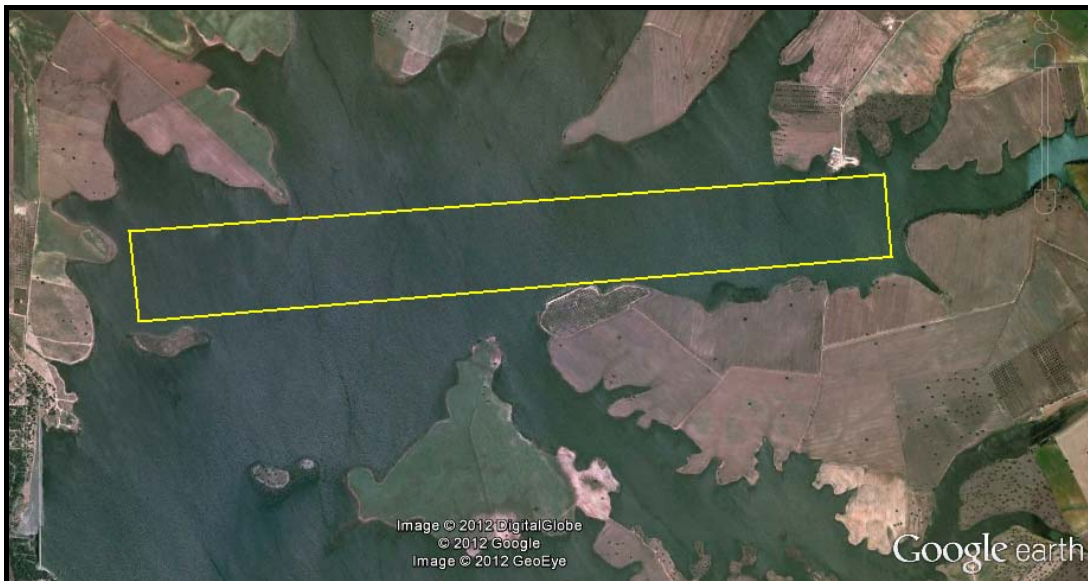
Picture Nr 6

Roxo Dam is located approximately 10NM Southwest of Beja military aerodrome and, at that time it was at a relatively high water level, which, given the absence of obstacles in its margins, no significant high grounds and no electric power lines in the zone, rendered it favourable for scooping operations. Taking a true heading of 265° (the wind was blowing from 310°), it was possible to draw a virtual runway with 13100ft X 1300ft (*picture nr 6*), well above the needs for this kind of aircraft operations.

After a sequential take-off, by 12:10, the four aeroplanes flew in group towards "Roxo Dam" and proceeded directly for scooping, always in group, on a true heading of 265° approximately, being that the best heading to grant the biggest and widest virtual runway available, more suitable for the group manoeuvre (*picture nr 6*).
